7A Flight Readiness Review (FRR)

International Space Station Program

International Space Station Program June 28, 2001

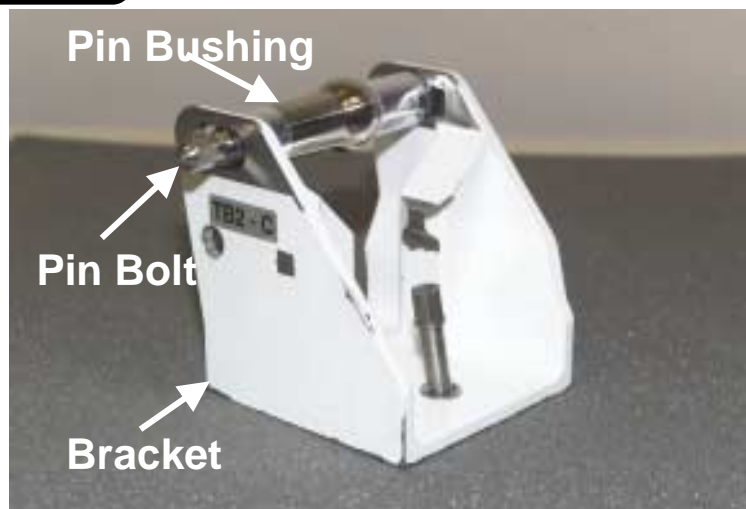
Support Brackets
Prior to Re-work

- Observation:
15-5PH stainless painted with BMS10-90 (Chemglaze II A276) subject to peeling
- Discussion:
HPGT Supt. Brackets painted to meet incidental touch temperature reqmts.
 - Paint is not adhering to the 15-5 stainless steel brackets
 - Paint will deteriorate after exposure to AO and UV environments
 - Search of other uses indicated HPGT thermal shields utilized same coating on 304 stainless

- HPGT ORU Support Brackets - Reworked per PR's and FEC-Airlock-032
 - Removed paint on bracket surfaces above the M/D shields and MLI blankets.
 - Applied 1.5 inch wide Permacel P213 glass tape on bracket surface.
- HPGT thermal shield brackets - Use as is per PR's
 - Paint adhesion and appearance is good based upon tape pull test and visual inspection
 - Thermal analysis indicates minimal degradation ($D < 2$ F)
- Risk Assessment: Low
- Ready for Flight: Yes
- Status: CLOSED

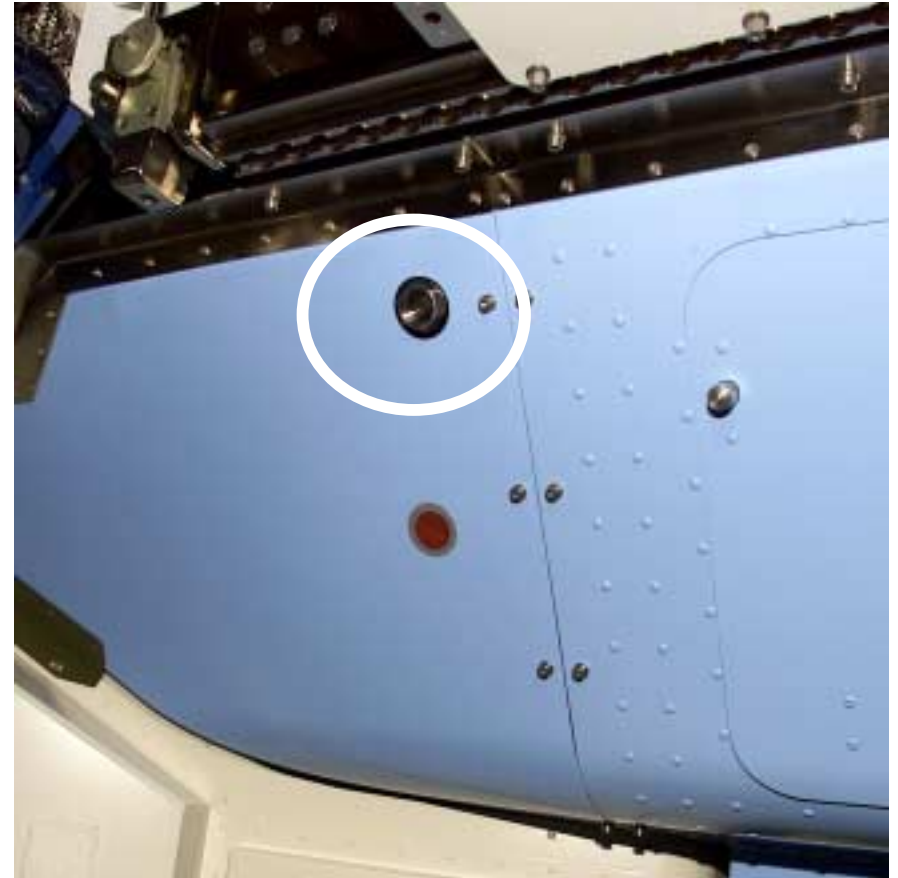
- Observation:
Current Airlock sample port design could allow MCA to give erroneous partial pressure readings
- Discussion:
Airlock sample port is recessed into close-out
Current configuration of Airlock sample port could sample mostly behind the close-out
Sample port should be in the direct flow of the cabin, especially during depressurization to 10.2 psia and during 10.2 psia operations
 - Possibly cause the oxygen partial pressure to exceed 30% during Airlock 10.2 psia operations
- Risk assessment: Low
CSA-CP as redundant method to monitor oxygen partial pressure at any location desired
EVA dry run on flight day 6 will be used to determine actual offset compared with CSA-CP

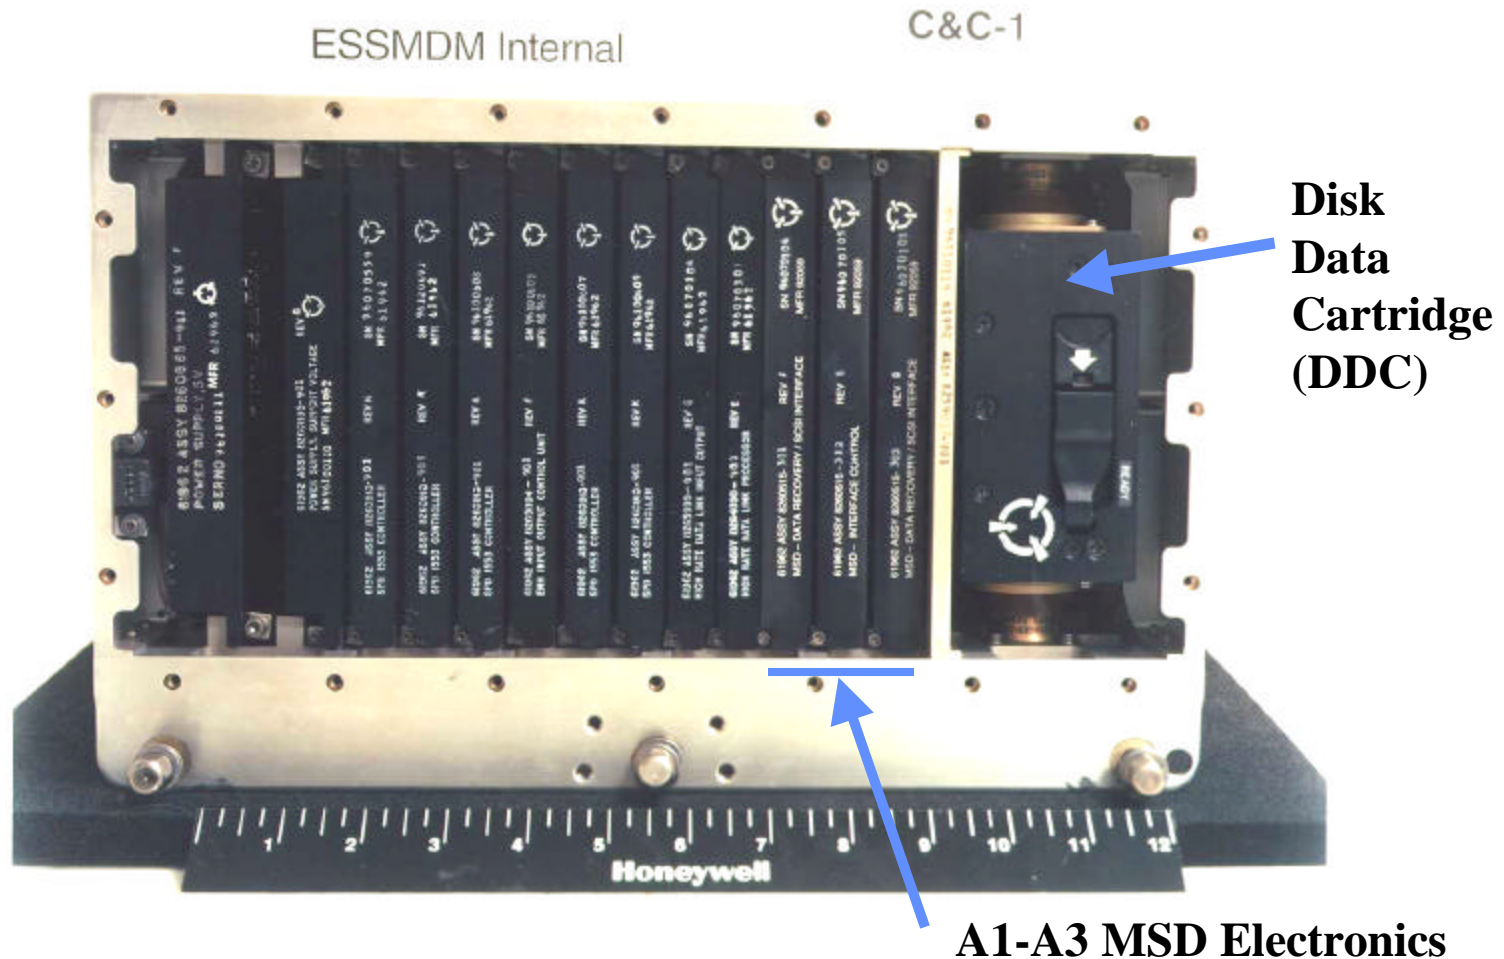
Mass Storage Device (MSD) Components in C&C MDM (Cover Removed)

- MDM returned on 6A- Postmortem on MSD by Raymond confirmed disk failure. 8 of 10 heads that read the disks are cracked.
 - Investigation ongoing as to what caused disk failure

- Mechanical Rotating Disk to be replaced by Solid State Memory
 - No moving parts
 - Improves reliability of SCSI interface
 - Reduced obsolescence and sparing issues
 - Increased capacity
- Prototype Solid State Units in place at SDIL and undergoing successful compatibility testing with CCS
- Program plan supports deployment this year
 - Available for phased deployment starting at 7A.1

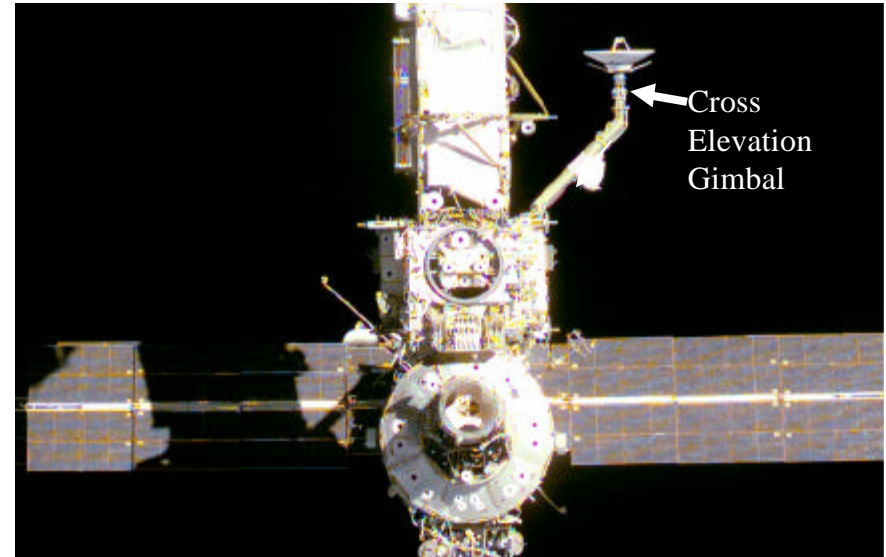
- Observations
 - Over time the temperature of the cross elevation gimbal of the Ku Band Antenna continued to gradually decrease
 - Documented at IFI 336
 - Testing revealed a failed heater circuit in the cross elevation gimbals
 - Pre-Mission planning set a minimum operating temperature of the Gimbals at 0 degC
 - Temperatures below the lower limits were observed in flight
- Discussion
 - A detailed review of relevant test data for the Antenna Assembly and its components indicates that revised operating limits can be used and preserve adequate margins of -20 degC for the Gimbal Motor and -30 degC for the Gimbal Encoder
 - Stepper motor design inherently protects gear train and other components from excessive torque
 - Recommendation approved by T&VCP 6/6/01, VCB 6/11/01 and ASCB 6/8/01
 - Implemented and operated within these limits
